Manhole Inspection Summary

Manhole # S29E__013MH

Insp Date: **9/23/08 10:38 AM**

Location Address: **701 Vine St**

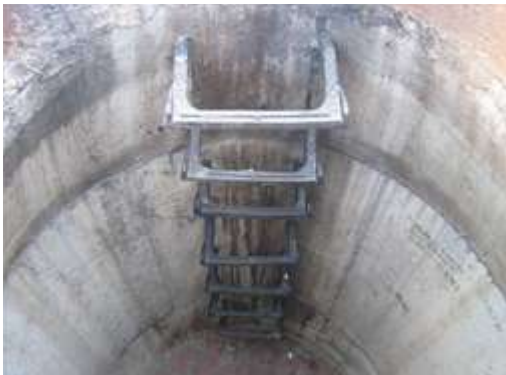
Miscellaneous

signs of previous frame/lid infiltration

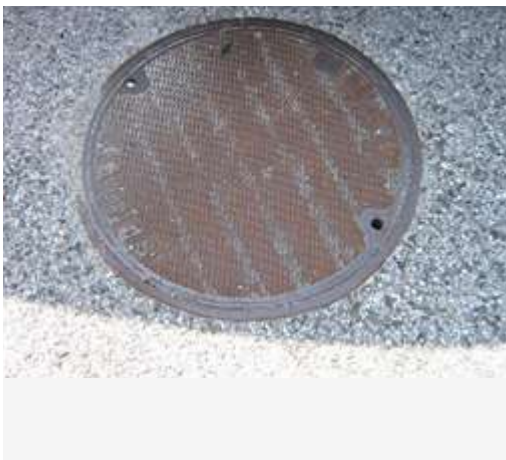
cover pic

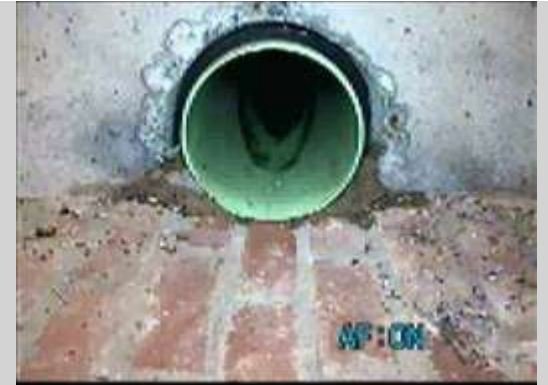
12 O'Clock Outflow

8 in. Circular Gravity Sewer
Pipe Out @ 12 O'Clock

Infiltration: **None** Pipe Seal Cond: **Sound**
